**AUTOSHOP / GSO**

**33<sup>rd</sup> DAE SAFETY MEET –  
2016 Organised by  
AERB & IPR, Gujarat.**

**ELECTRIC SHORT CIRCUIT DUE TO  
MECHANICAL FAILURE OF AN ACCELERATOR  
LEVER LINK ON A MOVING BUS**

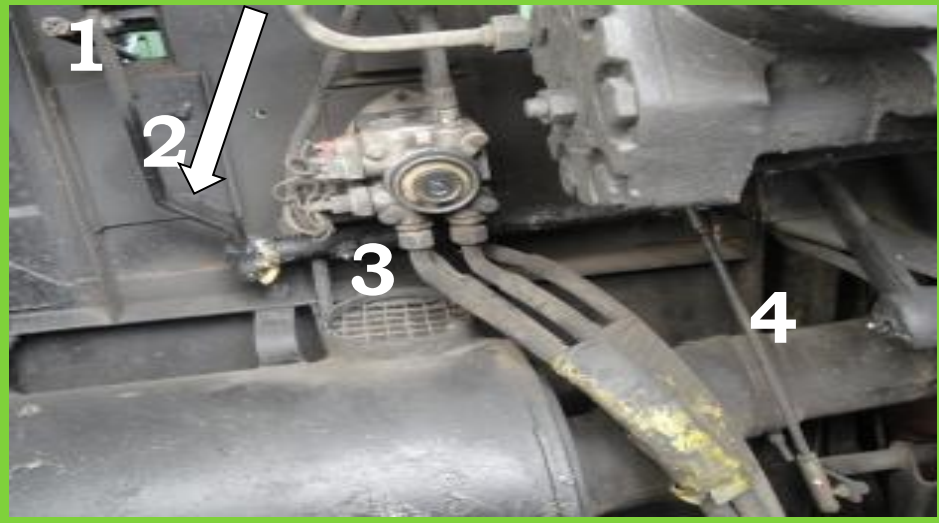
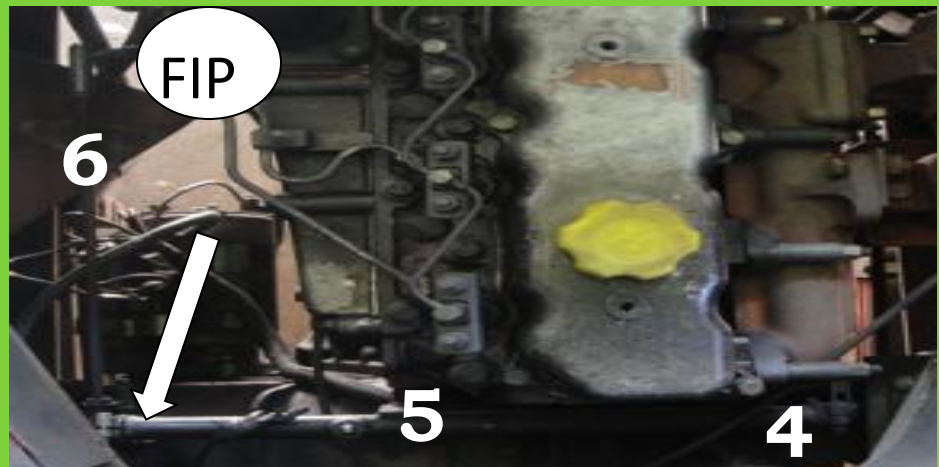
When the driver presses the Accelerator pedal the fuel injection pump lever will be activated through a series of linkages 1 to 6 as shown in figure.

The modulation of the pump lever is controlled by the driver based on the requirement of the speed.

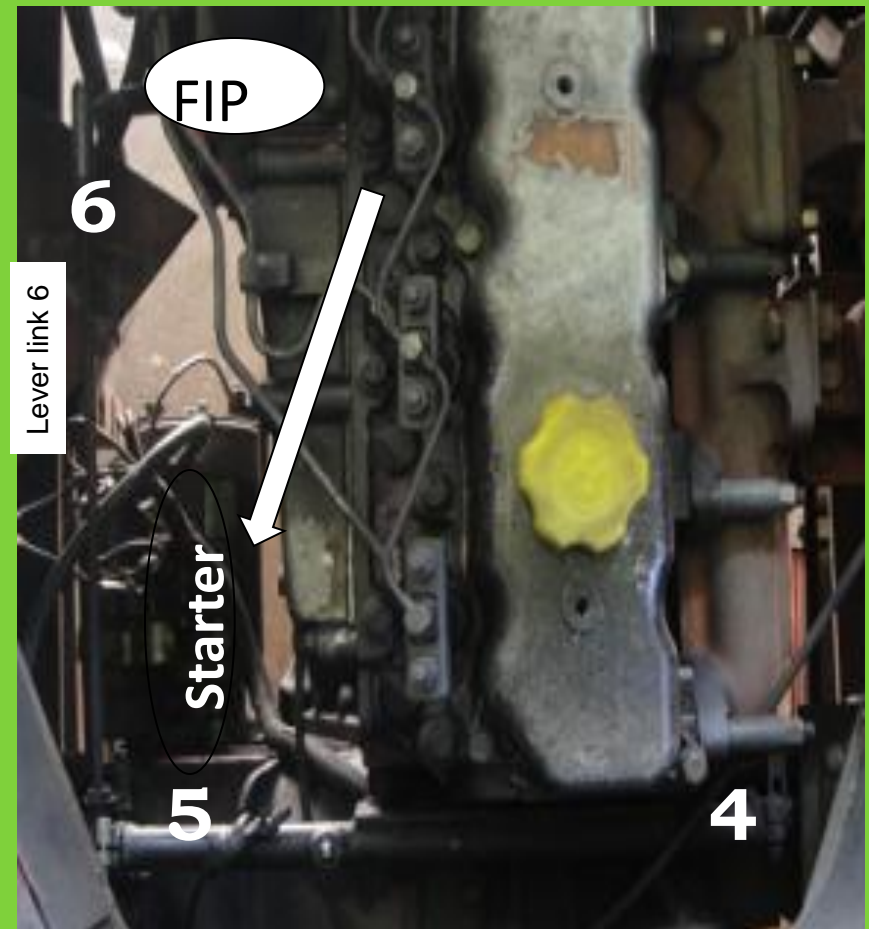
Position of the Starter Motor Assembly is **exactly below the lever link 6** as shown in the photo.

**LEVER LINK 6 IS A LONGEST LINK WITHOUT MIDDLE SUPPORT IN THE SYSTEM**

1. The lever **link 6 will fall/hang from one side hinged and touches** the starter motor power connections.

2. Since the whole body of the vehicle (including lever link 6) is connected with the negative terminal for the wiring advantage by the manufacturer, **the falling lever link 6 will create a short circuit** with the positive terminal of the starter motor.

3. Because of this short circuit of the battery power source, the complete wires may be burnt and may **result in a fire accident.**

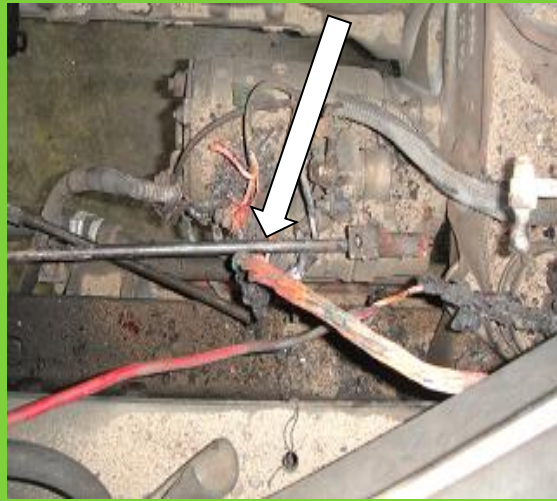
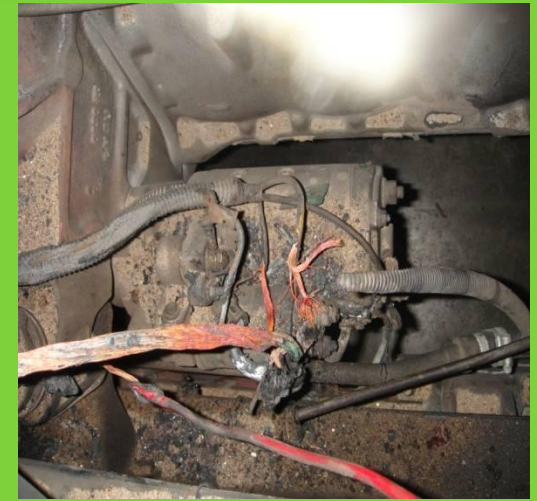
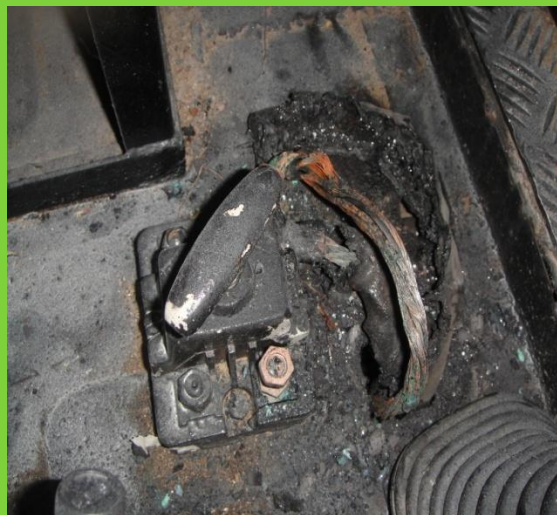
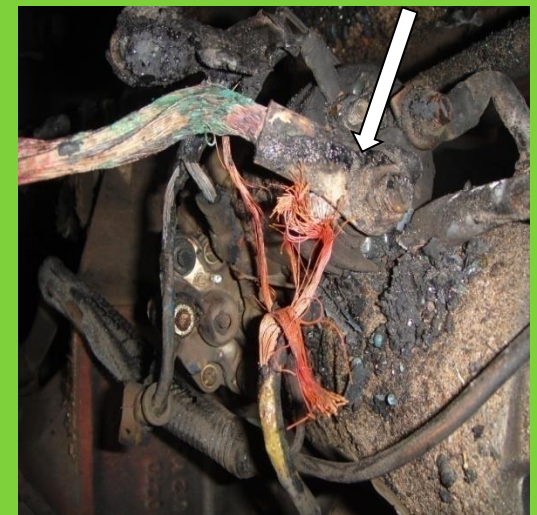
One of the GSO Bus TN 19 B 5325 faced with this lever link 6 failure and the complete wiring of the vehicle got burnt. The vehicle stopped on road and heavy smoke filled the vehicle. The fire extinguisher in the vehicle was used to extinguish the burnt wire & smoke, the short circuit was removed by the battery terminal cut off switch operation by the driver. There was no injury to any of the passengers.

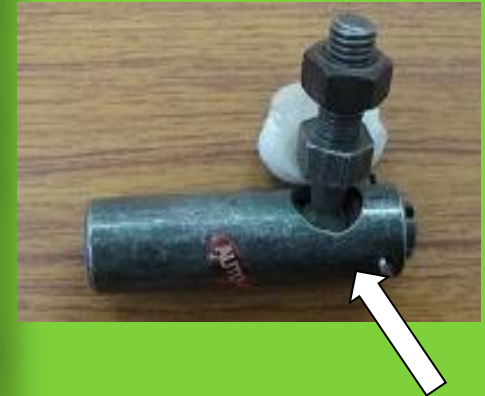
Since the ball joint is at the middle portion of the engine, it is **continuously exposed to heat**. The continuous heating reduces the lubrication partly. Hence, the insufficient lubrication led to **the ball wear out, accumulate, slip** from its position and leave the lever link to fall down.

At present, there is no fixed replacement schedule followed for the ball joints in the levers
